NAVAL RESEARCH LAB WASHINGTON DC
FAILURE ANALYSIS OF ROLLER CHAIN DRIVES.(U)
APR 80 F R STONESIFER, H L SMITH, D A WEYN
NRL-MR-4202

4. TITLE (and Subtitle) FAILURE ANALYSIS OF ROLLER CHAIN DRIVES		5. TYPE OF REPORT & PERIOD COVERED
7. AUTHOR(s) F. R. Stonesifer, H. L. Smith, and D. A. Meyn		6. PERFORMING ORG. REPORT NUMBER

FAILURE ANALYSIS OF ROLLER CHAIN DRIVES

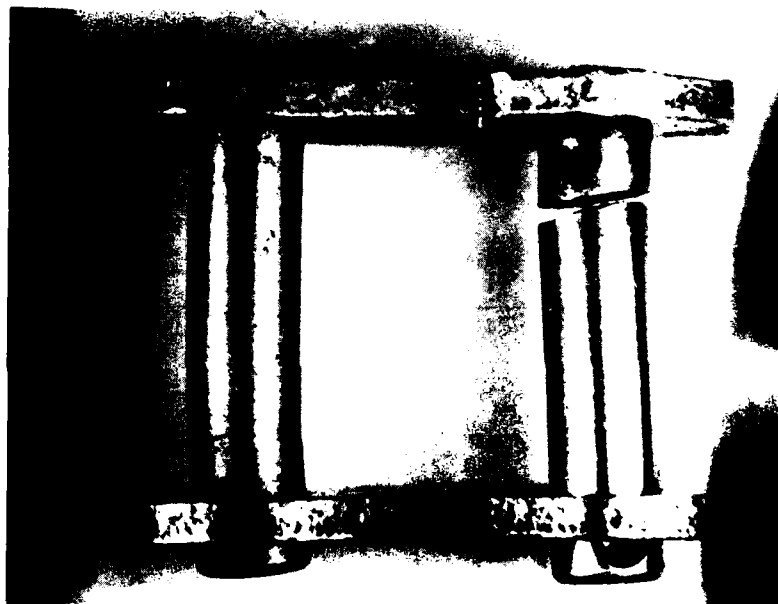
A pin of the connecting link fixing the chain to the support block was broken approximately 0.110" from the link plate near the peened end, Fig. 1. Apparently a crack initiated on the tension side, assuming tensile loading of the chain and the associated bending in the pin. No significant pitting or fretting was evident. The pin was noticeably bent at the fractured end. The fracture surface is shown in Fig. 2 with the origin visible at the top of the figure. The pin is martensite with case hardening to a depth of 20 to 25 mils and a surface hardness of 62 to 63 R_C, Figs. 2 and 3. Although post-fracture corrosion obscured fracture surface details at the origin, the case fracture was predominately transgranular, with some small areas of intergranular failure, Fig. 4. The core fracture was completely transgranular. A longitudinal hairline crack was found in the pin extending in from the surface to the interface between the hardened case and softer core, but it was not near the fracture origin. The probable cause of failure is overloading. There is no indication that the pin was substandard in strength or hardness. Surface hardness of the pin was approximately 60 on the Rockwell C scale.

Supporting the overload hypothesis, the other pin in the connecting link was found to be bent and cracked in two places at the cotter pin end but did not separate, Figs. 1 and 5. The two cracks correspond to locations just inside and just outside the end of the roller bushing on the tension side of the pin. The cotter pin, which constrains the link plate, had sheared off allowing the plate to move out and impose high bending stresses on the end of the pin.

Fig. 1 — The double cotter type connecting pin link which failed in June 1979. Note the bending in the fractured pin. Note the indentation and cracks near the end of the other pin. This was an in-service failure photographed at 3.5X.

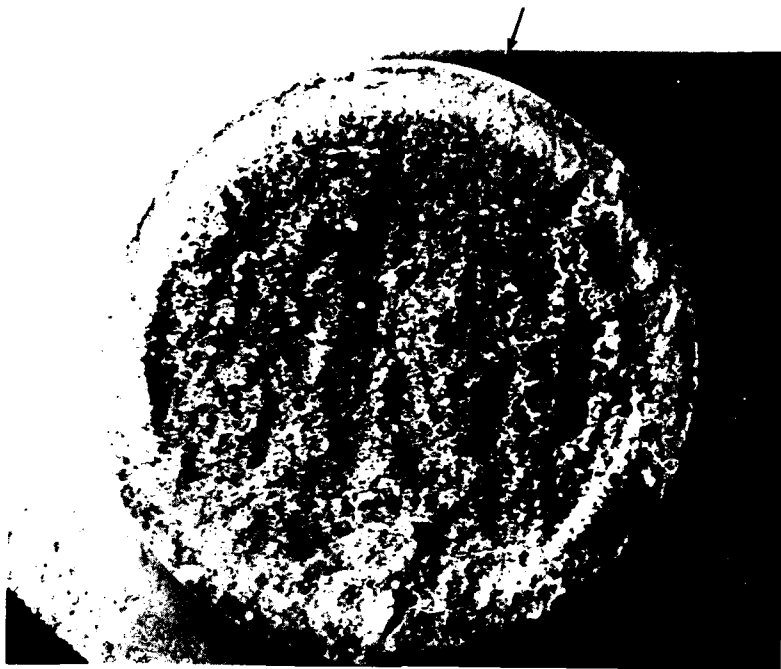
Fig. 2 — This SEM macrograph of the fracture surface from the June failure shows the fracture origin (see arrow). Depth of the core hardening can be inferred to be 0.020 in. to 0.025 in. from the fracture appearance. (16X).

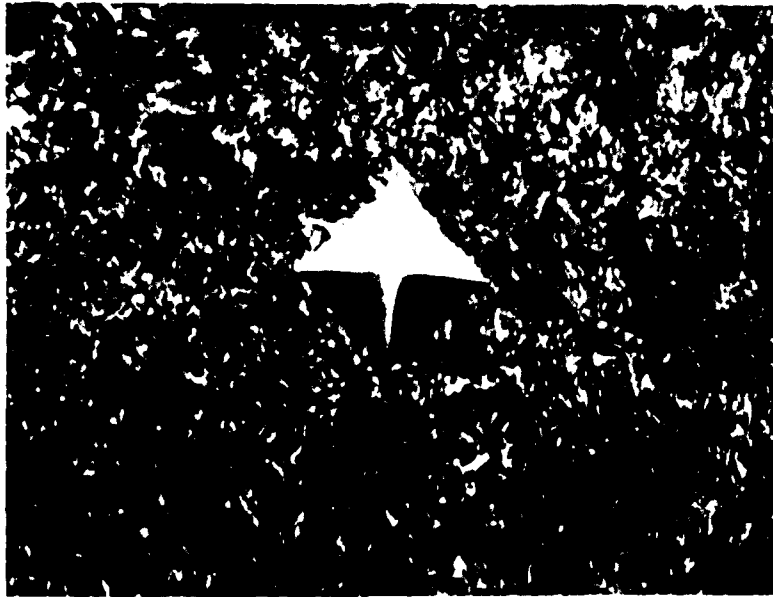
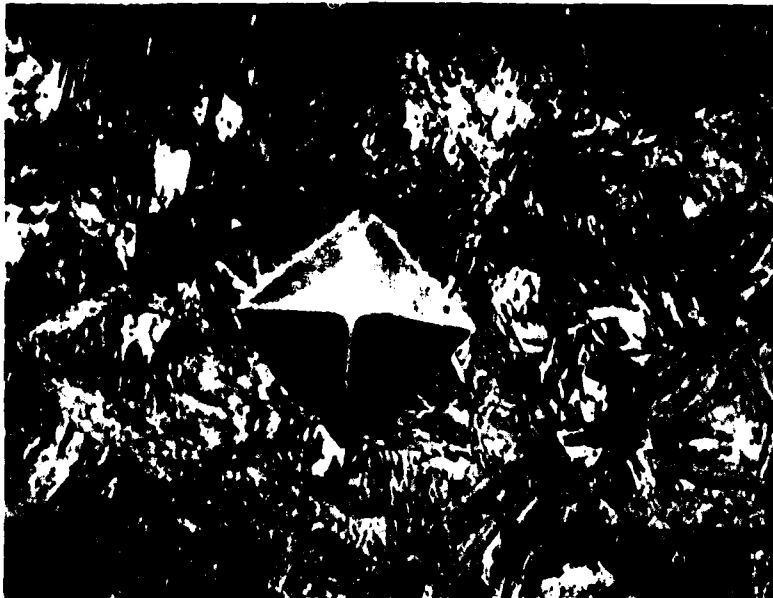
(a) Fine martensite in hardened area 0.006 in. from the pin surface. Small indent connotes high hardness.

(b) Coarser martensite in core of pin. Larger indent connotes lower hardness.

Fig. 3 — Polished and etched cross-section of the June failed pin shows structure and microhardness indents. (1000X).

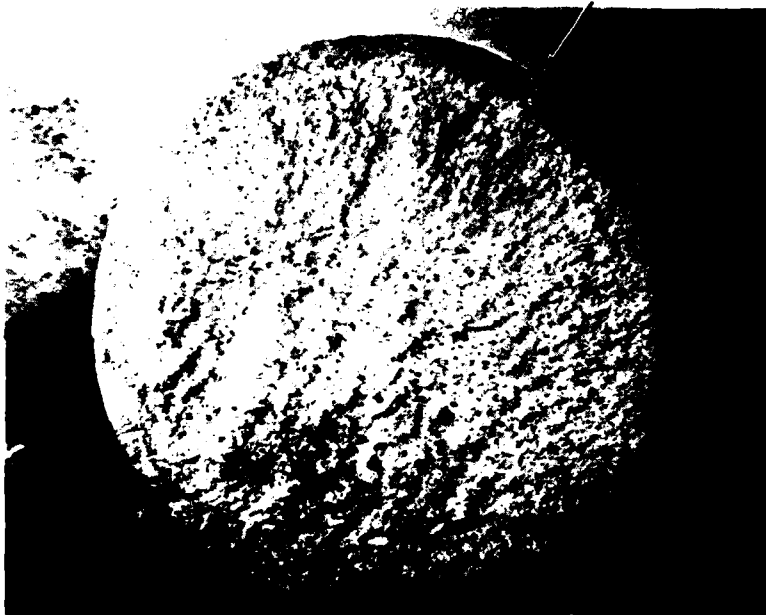
The pin at the support block end of the connecting link broke near its peened end, about 0.130" inside the link plate. Origin is at a corrosion pit, about 0.0016" deep, on the side of the pin subjected to tensile bending stress when the chain is loaded in simple tension, Figs. 6, 7 and 8. In this case, no permanent bend deformation was evident. The case fracture is intergranular to within a few mils of the origin pit where the surface becomes too corroded to determine the cracking mode. The case hardening depth is 0.020" to 0.025". Probable cause of failure is stress corrosion cracking, with some corrosion fatigue.

Fig. 6 — Macro photograph of fracture surface of pin from the July failure. The fracture origin is indicated by the arrow and is associated with a pit existing before the crack initiated. (16X).

- a) Replace the case hardened 1021 pins with pins of greater resistance to stress corrosion cracking, such as MP35N stainless steel.
 - b) Provide better surface finish of the pins to reduce circumferential surface gouges which serve as crack starters.
 - c) Replace the anchoring block when the hole becomes worn. This would minimize bending stresses in the connecting link pin.
 - d) Use a larger, thus stronger, size of chain or adjust system to reduce loading on present chain.
- 3) Use a commercially available stainless steel chain to reduce the corrosion problem. However, the lower rated load for such chain would necessitate an even greater reduction in loading if the present chain size is maintained.
